Subject: Supplemental Submission for Baxter Road and Sconset Bluff Storm
Damage Prevention Project (DEP File No. SE 048-2581)

**BAXTER ROAD AND SCONSET BLUFF STORM DAMAGE PREVENTION PROJECT
NOTICE OF INTENT (DEP FILE NO. SE 048-2581)**

**RESPONSES TO QUESTIONS FROM NANTUCKET CONSERVATION COMMISSION ASKED AT
PUBLIC HEARING ON AUGUST 28, 2013**

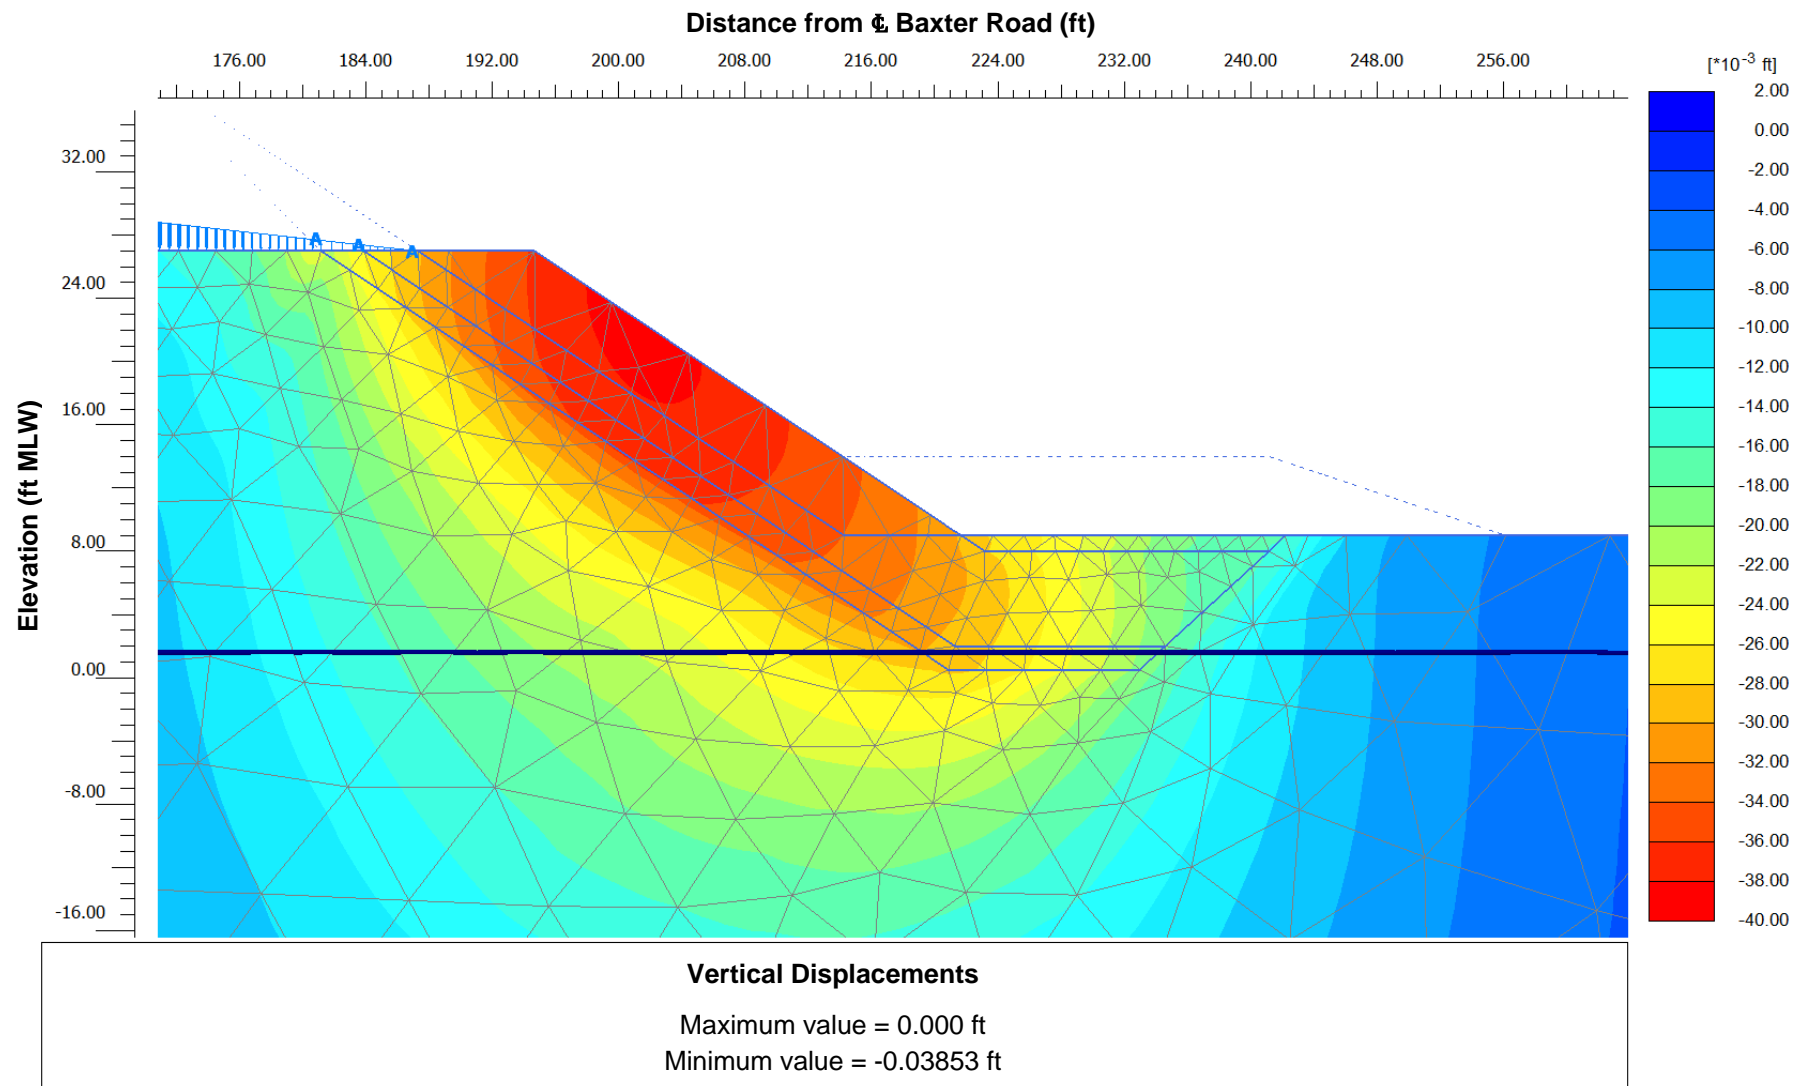
Figure 2. Plaxis results – Vertical settlements of proposed revetment without sacrificial berm at toe.

Two conditions of the proposed revetment were analyzed in Plaxis: (a) with a sacrificial sand berm at the toe (Figure 1); and (b) without the berm (Figure 2). The maximum potential vertical settlement for both conditions is only about 0.6 inch, which is negligible compared to the amount of sand removed and the revetment material placed and unlikely to affect the function of the proposed revetment. Note that more vertical settlements could be expected if weaker soils are actually found within the assumed extent of coastal beach sand.

“Two conditions of the proposed revetment were analyzed in Plaxis: (a) with a sacrificial sand berm at the toe (Figure 1); and (b) without the berm (Figure 2). **The maximum potential vertical settlement for both conditions is only about 0.6 inch, which is negligible compared to the amount of sand removed and the revetment material placed and unlikely to affect the function of the proposed revetment.** Note that more vertical settlements could be expected if weaker soils are actually found within the assumed extent of coastal beach sand.

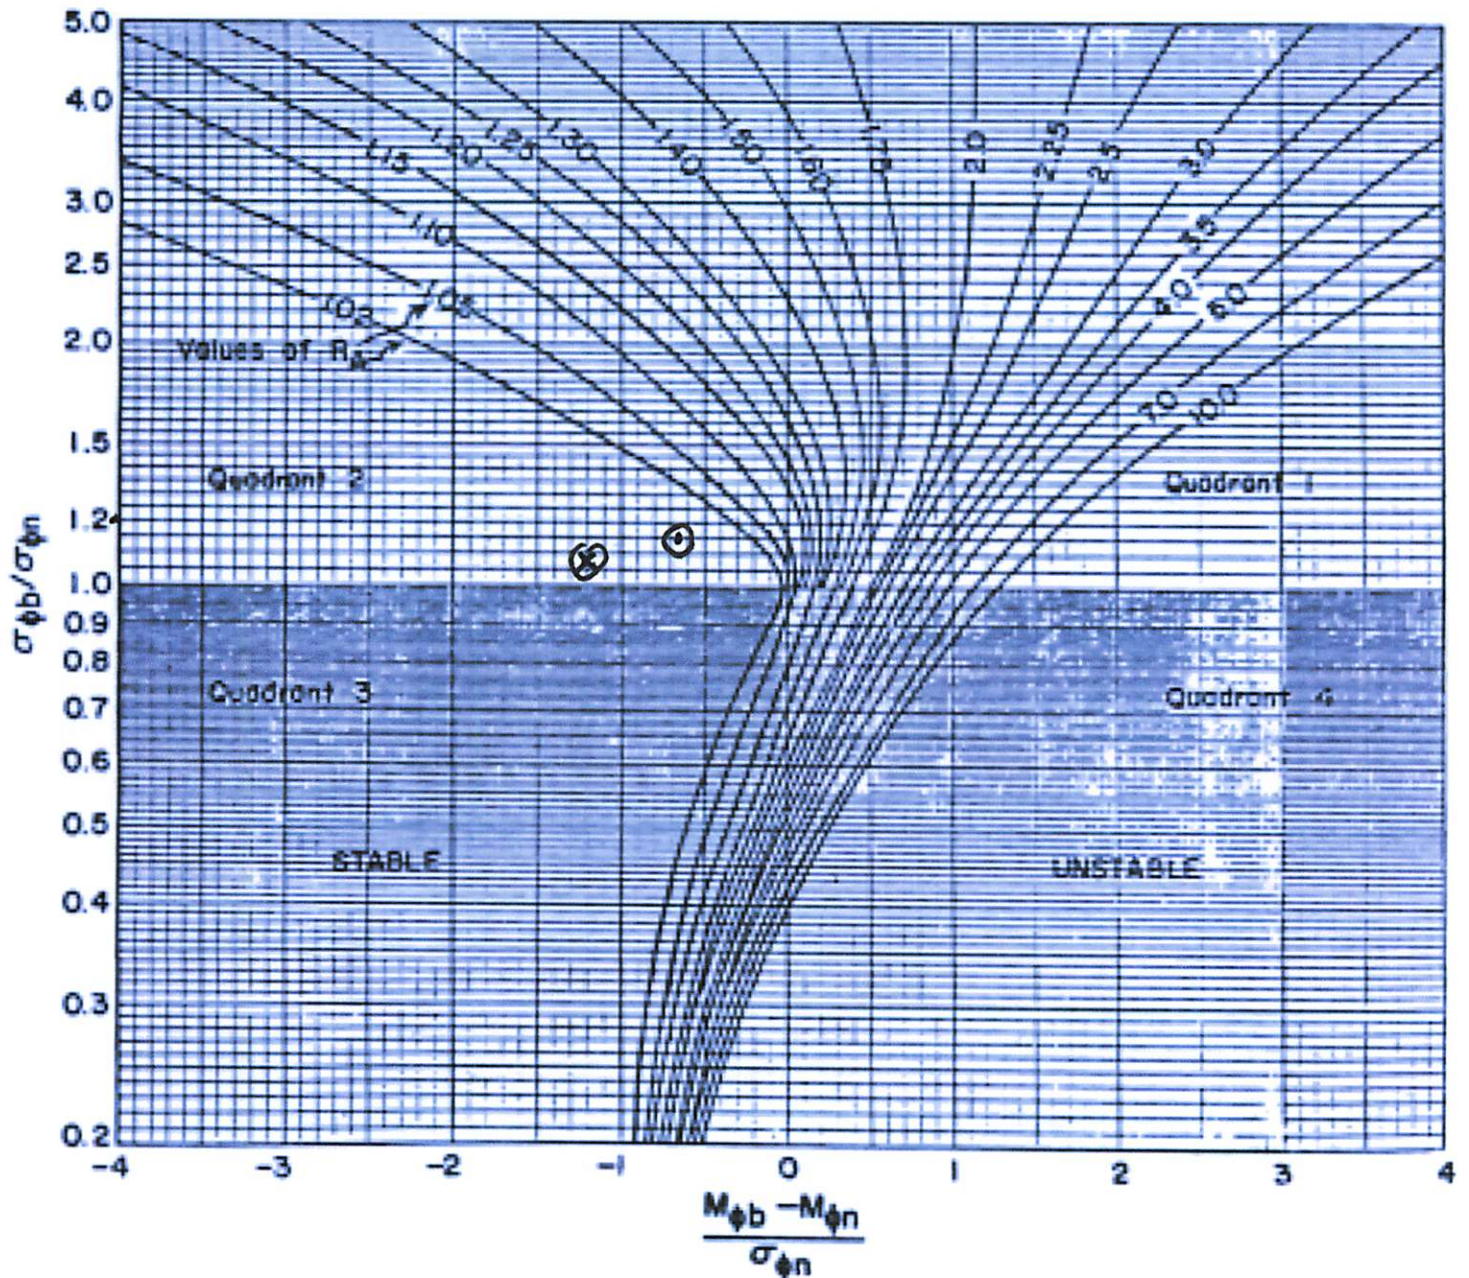
Sconset Beach James Overfill Calculation Worksheet
Borrow area to bank comparisons

JAMES OVERFILL FACTOR (R_A)

'BEACH': 2006 BANK COMPOSITE
FROM REVETMENT AREA.

SOURCE: \odot HOLOGATE
 \otimes REIS

I have evaluated the suitability of sand from two sand pits on Nantucket, Holdgate and Reis, for use to replace natural nourishment of beach sand from a portion of coastal bank on Baxter Road, Sconset, where a revetment is proposed.

I also reviewed earlier coastal bank samples in this area and noted that these composite samples were finer than the 2006 data. Therefore, 2006 is a worst-case of all the data available, and therefore yields a conservative estimate.
